# A Case Study: The Effect of Flooring Renovation with Adsorptive Cloth on the Residual Emissions of 2-ethyl-1hexanol and C9-C10 Alcohols

Miia J. Pitkäranta<sup>1,\*</sup>, and Timo Lehtimaa<sup>2</sup>

<sup>1</sup>Vahanen Building Physics ltd, Finland <sup>2</sup>Insinööritoimisto Sulin Oy, Finland

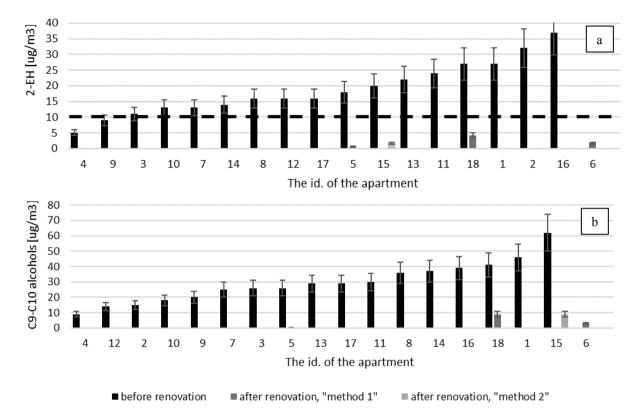
**Fig. 2.** Indoor air concentration of 2-ethyl-hexanol (a) and C9-C10 alcohols (b) in the case apartments before and after renovation. The black bars show the before renovation values and grey bars show the after renovation (control sample) values. The results are arranged in order of increasing VOC concentration before renovation. Most apartments were studied only before the renovation. The vertical dotted line in (a) shows the 10  $\mu$ g/m<sup>3</sup> action limit set by the Finnish Ministry of Social Affairs and Health for 2-EH. Error bars describe the ±19% uncertainty of the analysis.

The indoor air concentrations of 2-EH before and after renovation are shown in figure 2a and the concentrations of C9-C10 alcohols in figure 2b.

Before the renovation, 2-EH concentration in indoor air varied between 5 - 37  $\mu$ g/m<sup>3</sup> (average 19  $\mu$ g/m<sup>3</sup>). After renovation the concentration varied between 0,6 -4  $\mu$ g/m<sup>3</sup> (average 3  $\mu$ g/m<sup>3</sup>). In paired samples taken from the same apartment before and after renovation, the amount of 2-EH decreased by 84-97 %.

The measured concentration of C9-C10 alcohols in indoor air varied between 9-62  $\mu$ g/m<sup>3</sup> (average 30  $\mu$ g/m<sup>3</sup>) before the renovation. After renovation the concentration varied between 0,4 - 9  $\mu$ g/m<sup>3</sup> (average 5  $\mu$ g/m<sup>3</sup>). In paired samples taken from the same apartment before and after renovation, the amount of C9-C10 alcohols decreased by 88-98 %.

Repairing floors by removing the original flooring material and using cTrap decreased the ambient concentrations of 2-EH by 84-97 % and of C9-C10 alcohols by 88-98 %. After renovation the concentration of 2-EH was below the 10  $\mu$ g/m<sup>3</sup> action limit in all studied apartments. Also, the measured level of C9-C10 alcohols was <10  $\mu$ g/m<sup>3</sup>. No clear or consistent differences were seen between 'repair method 1' and 'repair method 2' apartments, however, the total number of "after-renovation' measurements was small (four apartments in total).

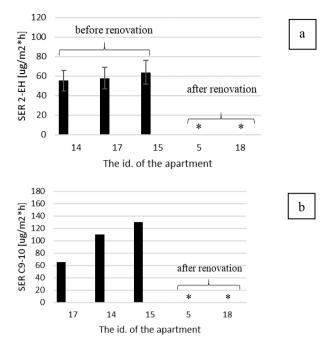
Before the renovation the surface emission rate varied between 55 - 64  $\mu$ g/m<sup>2</sup>h for 2-EH and between 65 - 130  $\mu$ g/m<sup>2</sup>h for C9-C10 alcohols (Fig. 3). The surface emission rates from the milled concrete surface of the apartment renovated by using "method 2" were 110

$\mu$ g/m<sup>2</sup>h and 130  $\mu$ g/m<sup>2</sup>h for 2-EH and C9-C10 alcohols, correspondingly. The measurement was done after the 3-week ventilation period but before cTrap installation.

After renovation including the installation of cTrap 2-EH and C9-C10 alcohols were no longer found (the emission rates were under the determination limit) (Fig 3).

**Fig. 3.** Specific emission rates of 2-EH (a) and C9-C10 alcohols (b) from intact floor surface measured before and after renovation. The results marked with an asterisk (\*) were below the determination limit of  $1 \ \mu g/m^2 h$ .

After renovation the originally elevated specific emission rates of the above-mentioned compounds were below the determination limit, so it can be concluded that repair successfully stopped the residual emissions of the VOCs from concrete and old screed to indoor air. The low levels of 2-EH and C9-C10 alcohols that still could be detected in indoor air after the renovation most probably derived from tertiary emissions of the compounds that had absorbed to other materials, such as ceiling and wall levelling and paint before renovation.
